## Corrosion on Mars: An Investigation of Corrosion under Relevant Simulated Martian Environments

Luz M. Calle,<sup>1</sup> Wenyan Li,<sup>2</sup> Jerry W. Buhrow,<sup>3</sup> Michael R. Johansen,<sup>4</sup> and Carlos I. Calle<sup>5</sup>  
NASA, John F. Kennedy Space Center, FL 32899

This research concerns the development of a systematic approach to understand corrosion of spacecraft materials on Mars, by conducting a literature search of available data relevant to corrosion in the Mars environment, and by performing preliminary laboratory experiments under relevant simulated Martian conditions. This work was motivated by newly found evidence for the presence of transient liquid brines on Mars that coincided with the suggestion, by a team of researchers, that some of the structural degradation on Curiosity's wheels, that cannot be attributed to rock scratching, may be caused by corrosive interactions with the brines. An extensive literature search, on data relevant to Mars corrosion, confirmed the need for further investigation of the effect of the Mars environment on the materials used for spacecraft and structures designed to support long-term surface operations on Mars. Sim

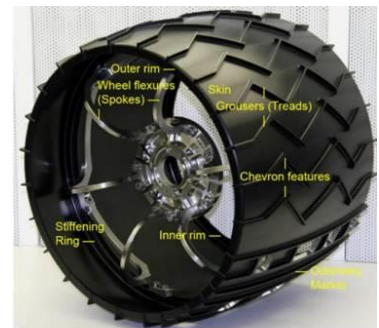
**Figure 1. Curiosity's wheel made from a single piece of machined aluminum alloy AA7075-T7351. The main rim is 1.9 cm thick (0.75-inches).**

Space-age aluminum alloys are lightweight, durable, extraordinarily strong, and their corrosion resistance is very good in most terrestrial environments. However, it is not known how aluminum and its alloys interact with the Martian environment. The Curiosity mission is just the latest example of aluminum's vital role in the development of modern aviation and mankind's exploration of space. Chosen for its lightweight and ability to withstand the stresses that occur during ground and launch operations, aluminum has been used on Apollo spacecraft, the Sky-lab, the Space Shuttles, and the International Space Station. Aluminum alloys consistently outperform other metals in areas such as mechanical stability, dampening, thermal management and reduced weight. "NASA could not have made it to the surface of Mars without aluminum."<sup>4</sup> The alloy used to make the thin-walled rigid wheel on the Mars Science Laboratory (MSL) is aluminum alloy AA7075-T7351 (Figure 1).<sup>5</sup> The wheel was made from a mandrel forged ring. It is hard anodized, a process used to increase the thickness of the natural oxide layer on the surface of the metal, for greater strength and improved corrosion resistance in terrestrial environments. The Mars mission, scheduled to launch in 2020, will use the same type of corrosion protection. This is understandable, given the fact that one of the most important factors in the design of the wheels is the mechanical strength required to transport heavy instruments across the rugged surface of Mars. The current state-of-the-art (SOA), regarding the selection of materials for landed spacecraft for human surface operations on Mars, is to assume that their corrosion behavior on Mars will be the same as that on Earth.

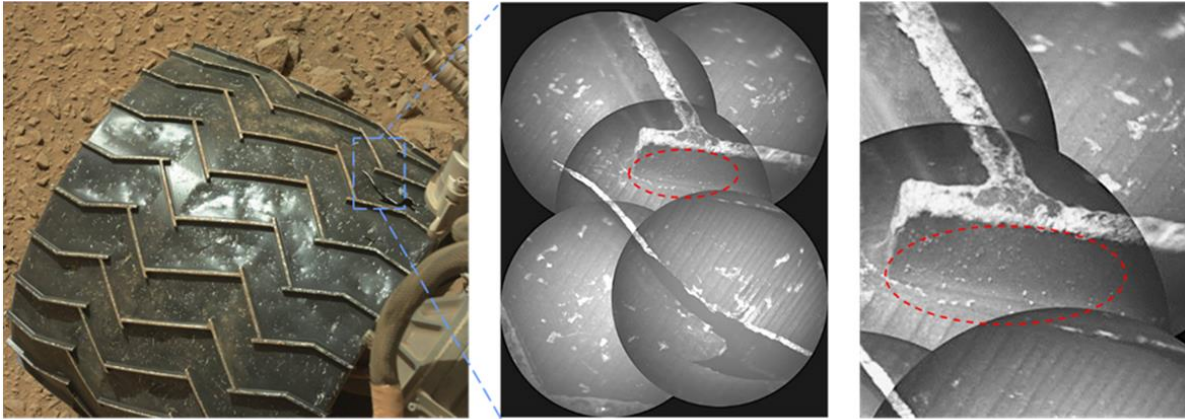
**Figure 2. Curiosity's ChemCam images of a damaged area of the rover's middle right-wheel. The image shows not only a large crack in the wheel (area inside blue rectangle on left image) but some sub-millimeter-sized blisters in the vertical wall of the T-print of the wheels (circled in red on the middle and right images) which cannot be attributed to rock scratching. It has been suggested that the blisters are caused by the corrosive interaction between transient brines and the aluminum alloy.**

Despite the overwhelming evidence that oxidation of materials is unavoidable on Mars, corrosion of materials has not been a major concern for Mars Missions, due to its arid atmosphere and the lack of evidence of liquid water. The recent discovery of perchlorates in the equatorial Gale Crater, in addition to the Phoenix lander finding it in the Martian arctic, supports the widespread presence of perchlorates on the surface of Mars.<sup>16</sup> Perchlorate and chlorate ( $ClO_3^-$ ) species have also been found in a Martian meteorite.<sup>17</sup> Its role in lowering the freezing temperature of water in Martian soil supports the presence of transient liquid water on Mars.<sup>7</sup> This new found evidence of liquid water (brine) coincided with the surprisingly significant damage observed on Curiosity's wheels (Figure 2). Soon after its landing, disturbing cracks started to appear on some of them. This was surprising, given that the design was similar to that of the Mars Exploration Rovers (MERs) Spirit and Opportunity, which never showed such a wear and tear when experiencing the same mean pressure (i.e. platform weight over wheel area in contact with a flat terrain). It has been pointed out that, maybe the daily contact of the wheels with the corrosive perchlorate solutions during every night have weakened the scratched surface of the anodized aluminum, making it more susceptible to damage against sharp rocks. Rover engineers concluded that the damage was caused exclusively by mechanical forces. Although the large cracks in the wheel are likely caused by mechanical damage, there is a pattern of distributed sub-millimeter-sized blisters in the vertical wall of the T-print of the wheels that cannot be attributed to rock scratching. This pattern resembles aluminum alloy pitting corrosion as shown on the image taken by the ChemCam remote microscopic-imager on sol 502 (Figure 2). A team of researchers<sup>9</sup> has suggested that, given the strong oxidizing character of perchlorate ions and their byproducts, the damage that cannot be attributed to rock scratching may be caused by corrosive interactions of brines with the aluminum alloy wheel.<sup>18</sup> Although perchlorates are not as corrosive as chloride ( $Cl^-$ ) anions, any Martian surface  $Cl^-$ -containing deliquescent brine would be expected to be very corrosive. In particular, for the Martian deliquescent brines, the  $Cl^-$  concentration in the Ca- and Mg-perchlorate eutectic concentrations are factors of 420 and 246 greater respectively than a diluted copper(II) chloride ( $CuCl_2$ ) solution (10 mM), which has been reported to cause 10-50  $\mu m$ -sized blisters with copper (Cu) deposits produced after Al pitting corrosion (similar to those circled in red in Figure 2) within 10 minutes.<sup>3</sup> Anodizing increases the thickness of the natural oxide layer on the aluminum wheels, but abrasion can wear out the external protecting layer and expose the internal aluminum to corrosion. The presence of chloride and perchlorate anions in brines may add stress to the aluminum wheels through pitting corrosion.

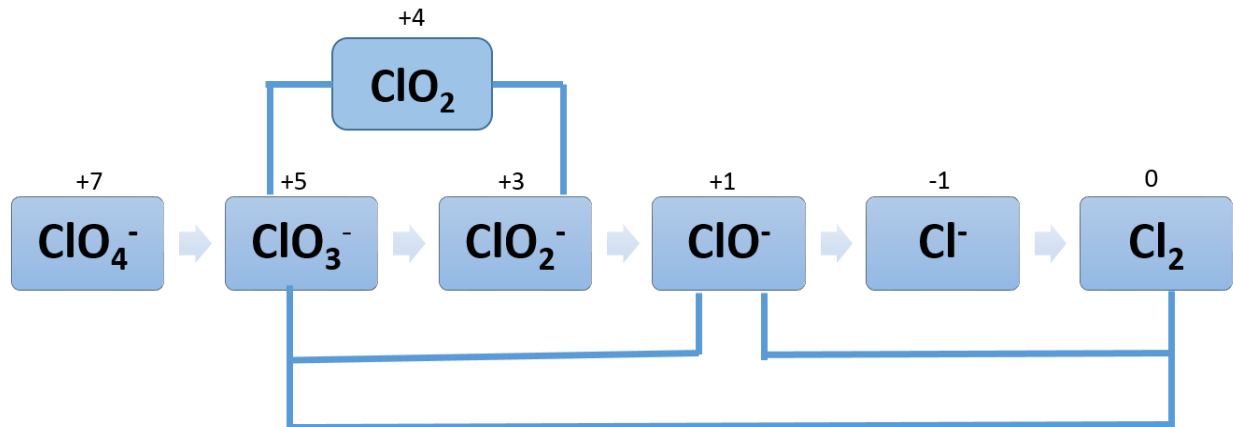
**Figure 3. Oxidation state diagram for oxychlorine species.**

Since the detection of perchlorates on Mars,<sup>17</sup> several studies have been aimed at understanding their effects on the habitability of the planet. The recent work of J. Wadsworth and C.S. Cockell<sup>40</sup> showed the significant bactericidal effects of UV-irradiated perchlorate on life at ambient temperatures and under Martian conditions. This finding is relevant to corrosion since it showed that, when irradiated with a simulated Martian UV-flux, perchlorate is more reactive at ambient temperatures and ambient conditions. The study also showed that two other components of the Martian surface, iron oxides and hydrogen peroxide ( $\text{H}_2\text{O}_2$ ), act in synergy with perchlorates to cause a 10.8-fold increase in cell death when compared to cells exposed to UV radiation after 60 seconds of exposure. The mechanism of perchlorate action on cells is likely to be its degradation to deleterious reactive oxygen species, such as hypochlorite ( $\text{ClO}^-$ ), commonly known as chlorine bleach, and chlorite ( $\text{ClO}_2^-$ ). Similar photoproducts have been previously observed in perchlorate irradiated with ionizing radiation.<sup>15,41</sup> Figure 3 shows the oxidation state diagram for oxychlorine species (with the oxidation number of chlorine shown on top). C.D. Georgiou *et al.*<sup>42</sup> reported that  $\gamma$ -radiolyzed perchlorate-containing Mars soil salt analogues (in a  $\text{CO}_2$  atmosphere) generate, upon  $\text{H}_2\text{O}$  wetting, the reactive oxygen species (ROS) superoxide radical ( $\text{O}_2^-$ ),  $\text{H}_2\text{O}_2$ , and hydroxyl radicals ( $\text{OH}^\bullet$ ). This study also validated the finding that analogue radiolysis forms oxychlorine species that, in turn, can UV-photolyze to  $\text{OH}^\bullet$  upon UV photolysis. Additionally, UV photolysis of the perchlorate  $\gamma$ -radiolysis product, chlorite ( $\text{ClO}_2^-$ ), generated the oxychlorine products trihalide ( $\text{Cl}_3^-$ ), chlorine dioxide free radical ( $\text{ClO}_2^\bullet$ ), and hypochlorite ( $\text{ClO}^-$ ), with the formation of  $^\bullet\text{OH}$  by UV photolysis of  $\text{ClO}^-$ .

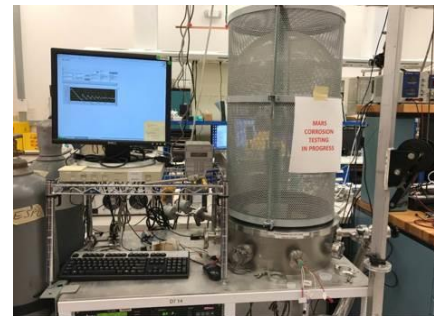
Figure 4. Mars chamber at KSC.

The Mars chamber offers the capability to select the chemical composition and pressure of the atmosphere inside and to control the pressure within a few mTorr through the use of an MKS Type 640 pressure controller with an external LabView® software monitor and control. The pressure and temperature inside the chamber were maintained at 700 Pa and 20°C. To get the appropriate mix of gases in the chamber, the chamber pressure was first reduced to less than 13.3 Pa (0.133 mbar) using a Varian TriScroll 300 scroll pump. The pressure was recorded once per minute for each long-duration experiment to ensure power outages or other system anomalies were not present during testing. The pressure stability for one experiment is displayed in Figure 5.

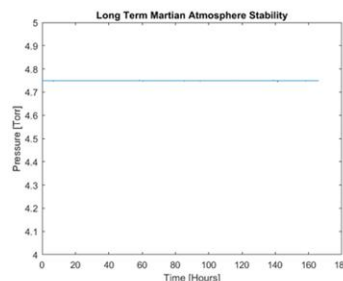
Figure 5. Pressure data from a representative long-term exposure experiment inside the Mars chamber (1 Torr = 0.133 kPa).

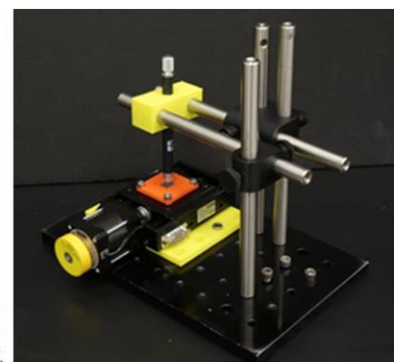
Figure 6. Sample holder with scribing tool.

The aluminum alloy test panels were scribed remotely inside the Mars chamber with a scribing set up designed and fabricated specifically for this project (Figure 6). Several design iterations were necessary to develop an adequate scribing tool for the aluminum alloy coupons. Ultimately, an optics table with a mix of stainless steel and acrylonitrile butadiene styrene (ABS) 3D-printed components was used in the final design. A Micos VT-80 translation stage, with LabView® control, was used to move the scribing tool across the surface of the aluminum alloy sample. The optics table and stainless steel rods provided the structural rigidity needed to withstand the forces applied when scribing the aluminum alloy surface with the silicon carbide tip.

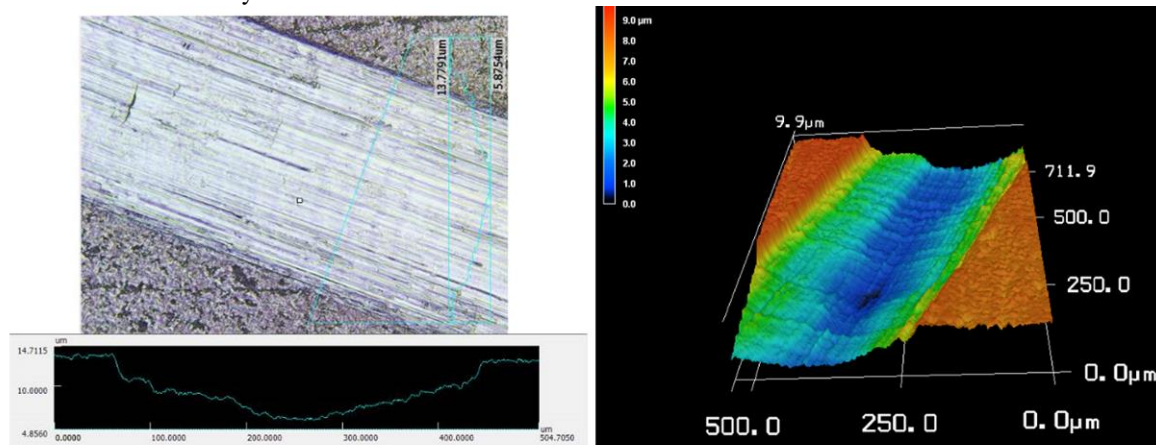
**Figure 7. Cylindrical carbide scribe profile imaged using laser confocal microscopy.**

A variety of scribing tips were used to achieve the proper scribe dimensions needed for the XPS analysis described in the following section. The goal was to have a wide shallow channel scribed into the aluminum alloy sample. The profiles created by these scribing tools were observed using laser confocal microscopy to select the best scribing tool. A cylindrical carbide scribe tool was selected. The channel profile could be adjusted by angling the scribe tool. To create an adequately wide and shallow profile, as shown in Figure 7, the scribe tool was

angled roughly 25 degrees from parallel to the aluminum alloy sample. The confocal microscopy images show that the scribe channel is 250  $\mu\text{m}$  wide with a large radius of curvature and maximum depth of 9  $\mu\text{m}$ . This profile was the most suitable for XPS analysis.

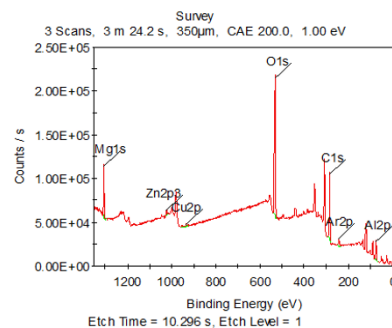
**Figure 8. Typical survey scan for AA7075-T73 aluminum alloy**

Figure 8 shows a typical survey scan of AA7075-T73 aluminum alloy where the main peaks are labeled with the elements present: Al, Mg, Zn, Cu, O, and C.

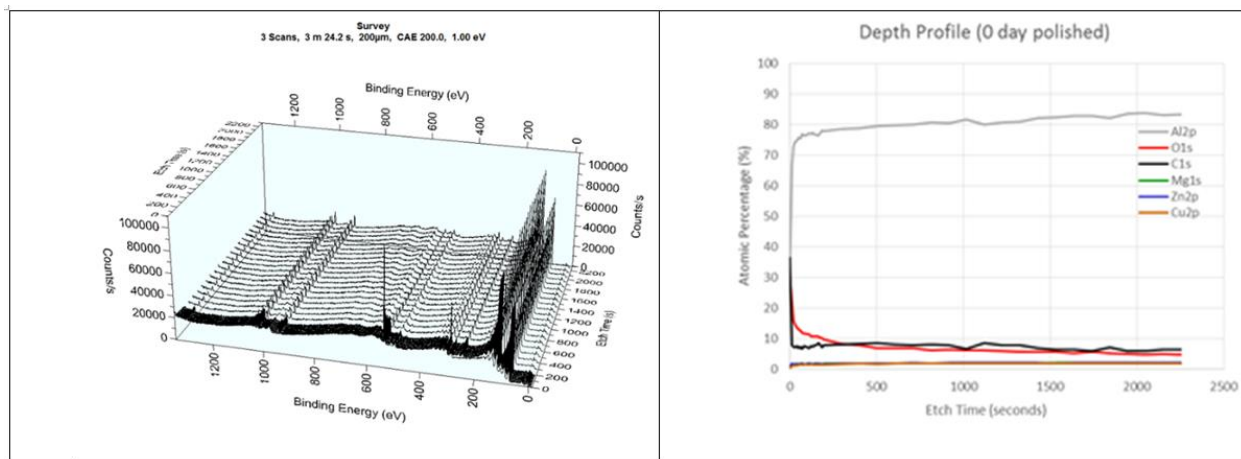
**Figure 9.** Survey scan and depth profile data collected over the scribed area of an AA7075-T73 aluminum alloy sample immediately after exposure to the air (“0-Day-Air exposure” sample).

An AA7075-T73 aluminum alloy sample was polished and scribed in air, before transfer to the XPS chamber for analysis. This sample was used as a control. The scribed area was unavoidably exposed to air (for about 5 minutes) before the XPS analysis. XPS composition depth profile data was collected at the scribed area (Figure 9 and Figure 10); the total etch time was more than 2000 seconds, at an experimental setting where one second of etch time corresponds to 0.35 nm tantalum pentoxide ( $\text{Ta}_2\text{O}_5$ ).

The depth profile for oxygen is indicative of slight oxidation at the scribe that resulted from the brief exposure to the oxygen in the air. Below the top surface layer, the carbon content is relatively low but it is present through the whole depth profile. The high carbon content on the sample surface is due to adventitious carbon contamination. The other elements are present in the expected composition range.

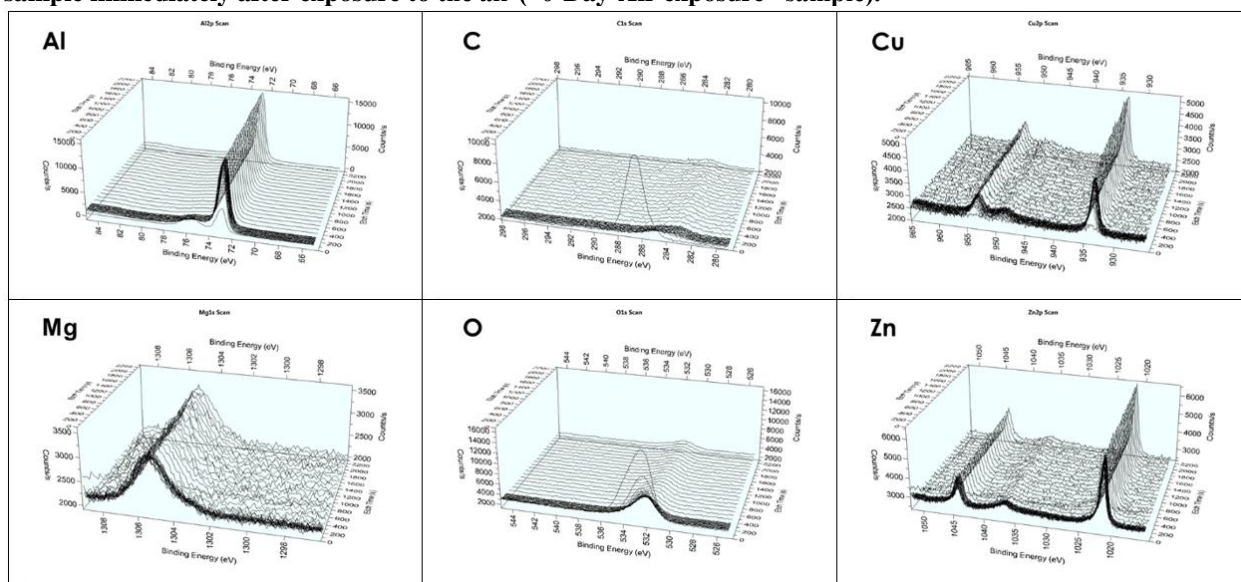
**Figure 10.** Depth profile data, for individual elements, collected over the scribed area of an AA7075-T73 aluminum alloy sample immediately after exposure to the air (“0-Day-Air exposure” sample).

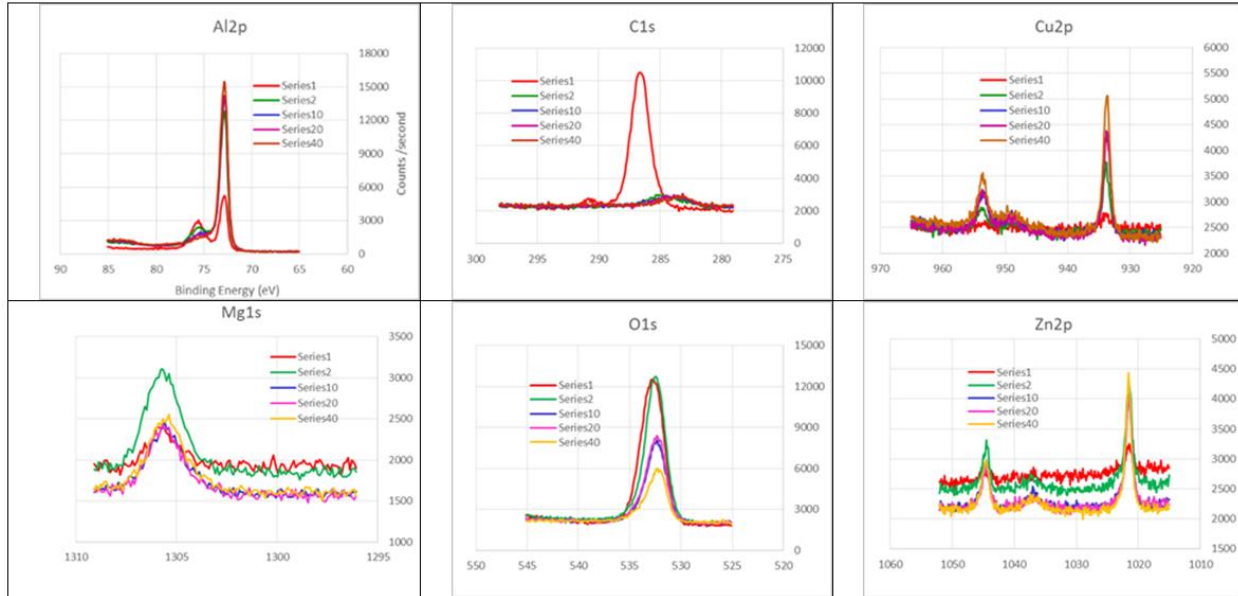
**Figure 11. Selected spectra of individual element scans from the depth profile of AA7075-T73 control sample (minimal exposure to air of the scribed area).**

Figure 11 shows selected spectra of element scans from the depth profile: series 1, 2, 10, 20, and 40 that correspond to the etch times of 0, 10, 90, 190, and 2190 seconds. Figure 12 shows the same depth profile plot shown in Figure 9 zoomed in for 0-500 second etch time and for 0-10 atomic percentage to show the elements (Cu, Zn, and Mg) that are present at low level. Both sets of data show that there is some slight surface enrichment of Mg and Zn (between 0 and 100 seconds etch time). Their atomic percent compositions are relatively constant, whereas Al and Cu show a gradual increase as the O content decreases away from the surface.

The observed Mg and Zn enrichment is consistent with similar results obtained by C.M. Abreu *et al.*<sup>60</sup> who performed an XPS study that included AA7075-T73. Their results showed a Mg<sup>2+</sup> enrichment, very similar to the Mg enrichment obtained in this study. They attributed it to the formation of magnesium oxide (MgO). In summary, the results for the control (labeled as 0-day-air exposure) AA7075-T73 aluminum alloy sample, briefly exposed to air, showed a slight oxidation on the surface, a low carbon content through the depth profile (less than 1 micron from the surface) which can be attributed to adventitious carbon contamination from an unknown source, and a slight surface enrichment of Mg and Zn (less than 50 nanometer from the surface).

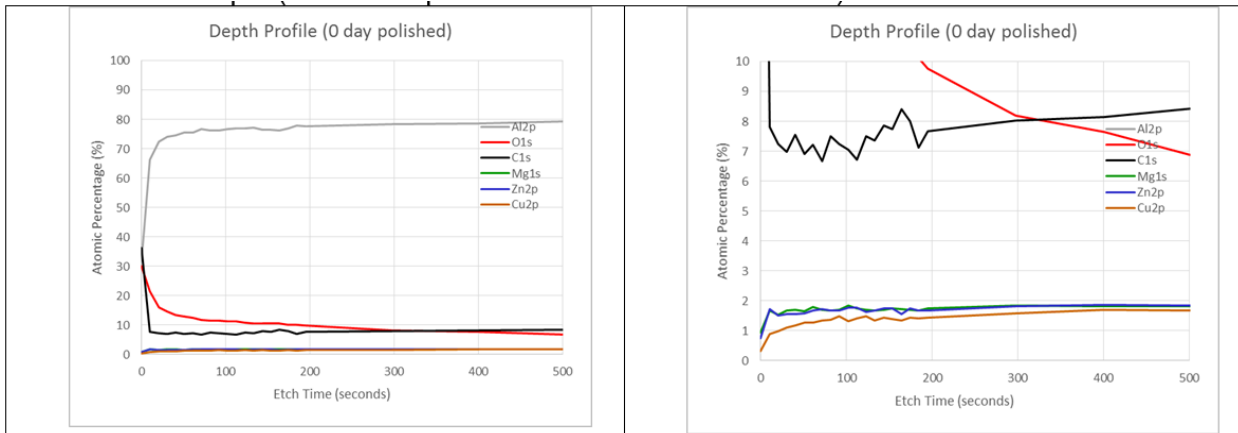
**Figure 12. Depth profile data collected over the scribed area of an AA7075-T73 aluminum alloy sample, immediately after exposure to the air (“0-Day-Air” sample), zoomed in for 0-500 seconds etch time (left image) and for 0-10% atomic percentage (right image).**

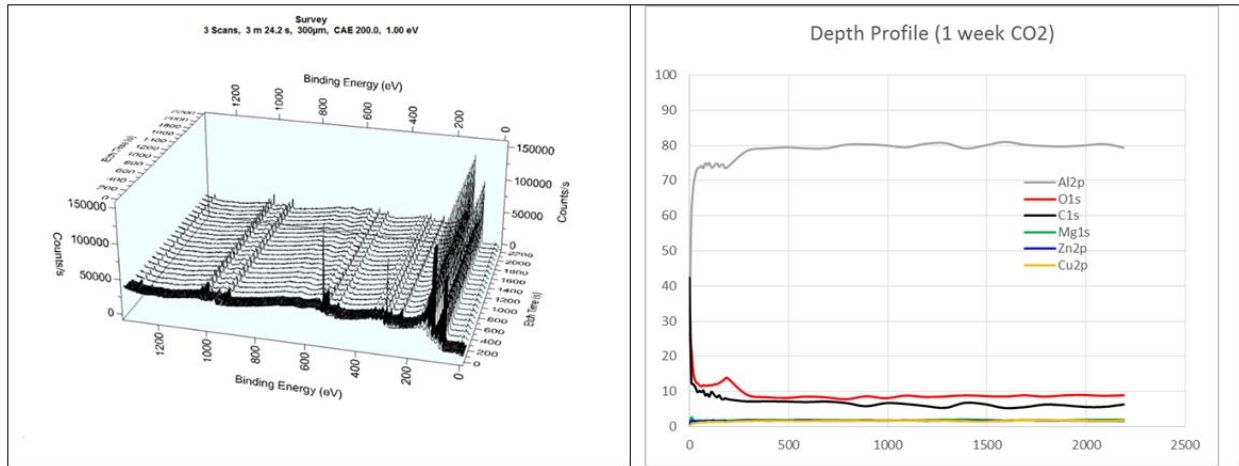
Figure 13. Survey scan and depth profile data collected over the scribed area of an AA7075-T73 alloy sample exposed to CO<sub>2</sub> for one week at 700 Pa (7 mbar) pressure and room temperature.

Figures 13-15 show the survey scan and depth profile data collected over the scribed area of an AA7075-T73 aluminum alloy sample after one week of exposure to CO<sub>2</sub> at room temperature and 700 Pa of pressure. Figure 16 shows selected spectra of element scans. The oxygen content was lower than that of the sample exposed to air for one week but slightly higher than that of the control sample. This can be attributed to a possible chemical interaction between CO<sub>2</sub> and the sample. Unlike the AA7075-T73 sample that was exposed to air for one week, the aluminum peak does not have a significant higher binding energy component (indicative of a metal oxide or carbonate) below the surface, which can be interpreted as an indication of a weak interaction between aluminum and the CO<sub>2</sub> environment. The other elements were present in the expected composition range. There was some surface enrichment of Mg and Zn where the Mg enrichment was slightly more pronounced.

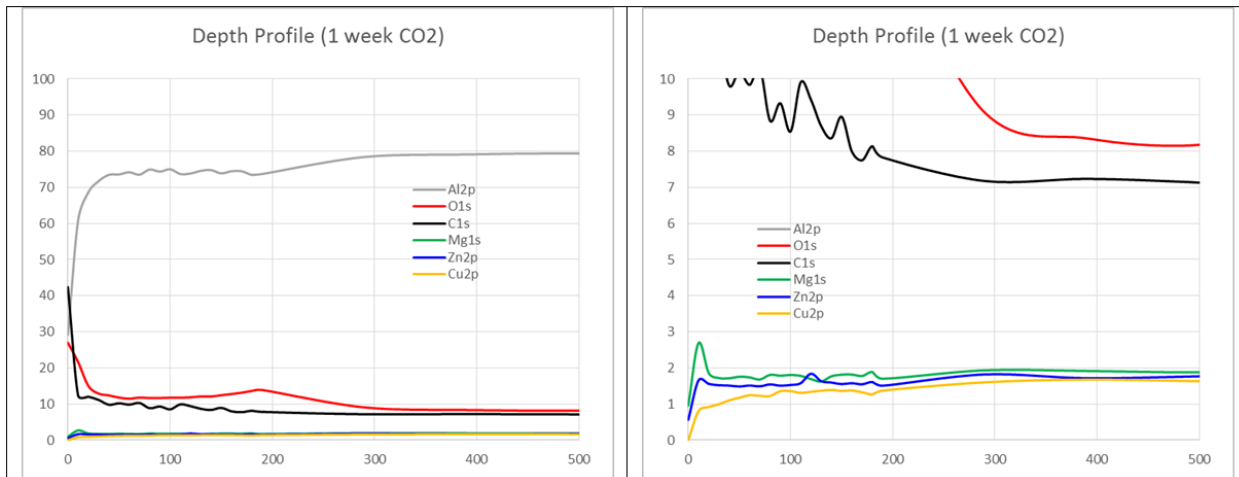
Figure 14. Depth profile data collected over the scribed area of an AA7075-T73 aluminum alloy sample, immediately after exposure to CO<sub>2</sub> for one week, zoomed in for 0-500 seconds etch time (left image) and for 0-10 atomic percentage (right image).

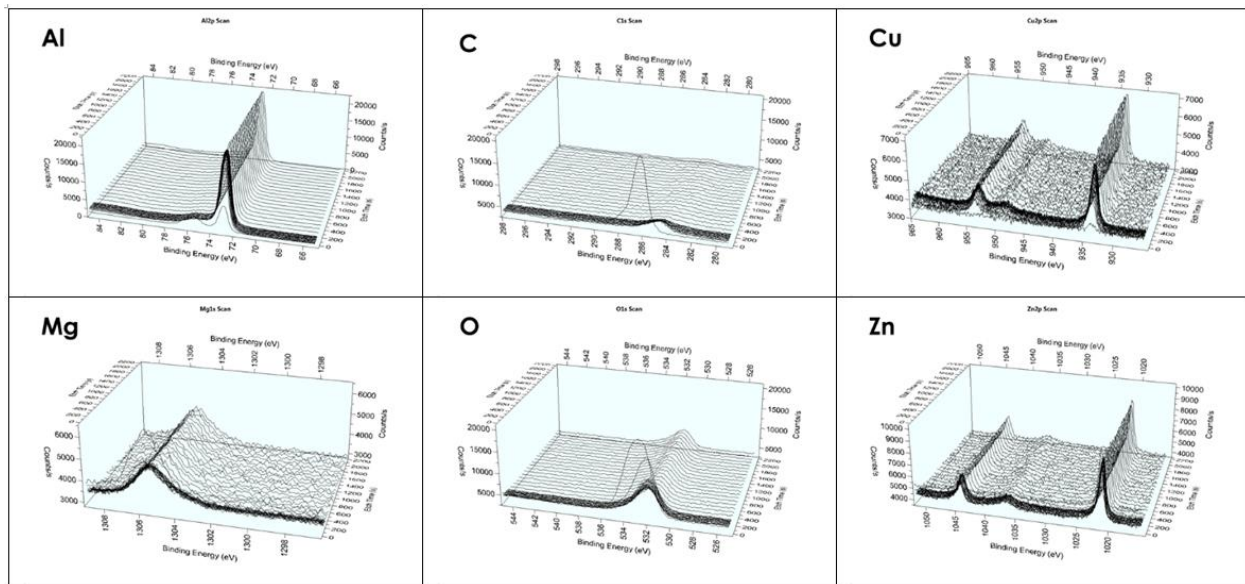
**Figure 15. Depth profile data, for individual elements, collected over the scribed area of an AA7075-T73 alloy exposed to CO<sub>2</sub> for one week at room temperature and a pressure of 700 Pa.**

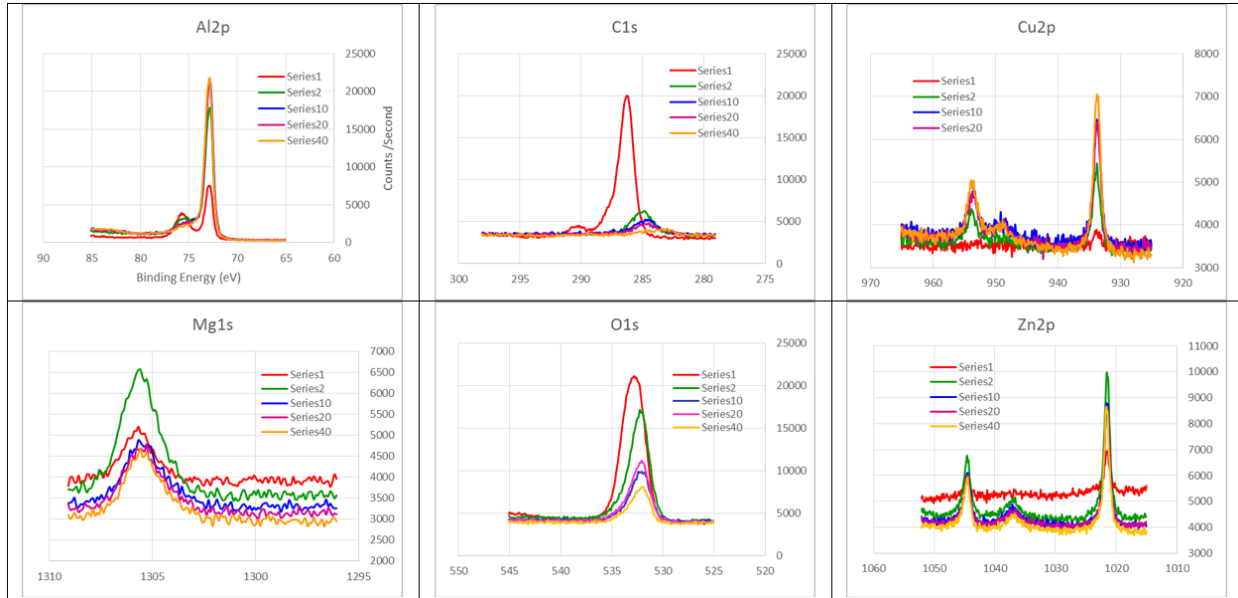
**Figure 16. Selected spectra of individual element scans from the depth profile data collected over the scribed area of an AA7075-T73 alloy sample exposed to CO<sub>2</sub> for one week at 20°C and a pressure of 700 Pa.**

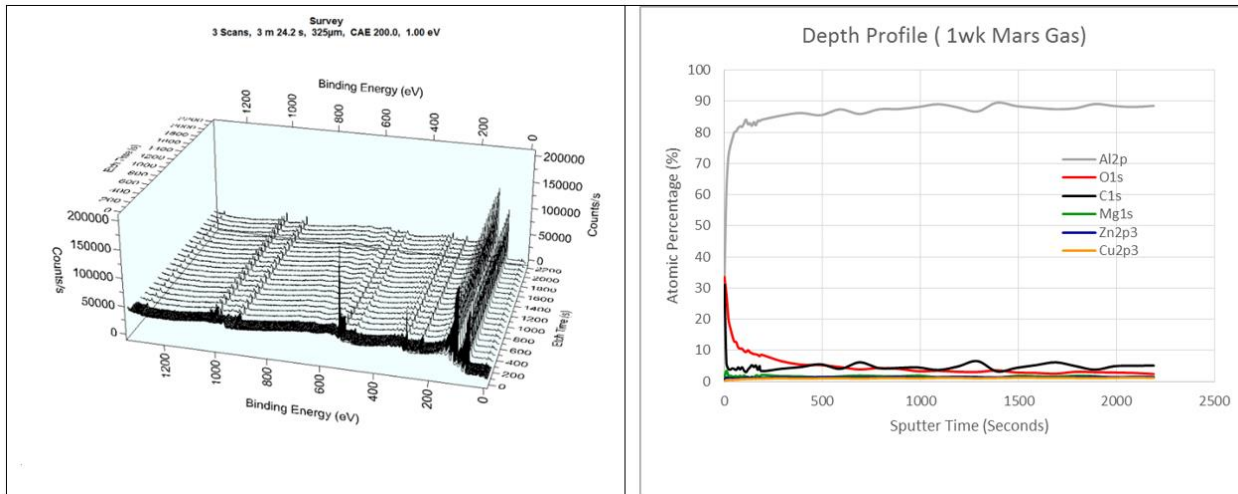
**Figure 17. Survey scan and depth profile data collected over the scribed area of an AA7075-T73 alloy sample exposed to Mars Gas for one week at a temperature of 20°C and a pressure of 700 Pa.**

Figure 17, Figure 18, and Figure 19, show the survey scan and depth profile data collected over the scribed area of an AA7075-T73 aluminum alloy sample after one week of exposure to Mars gas at 20°C and 700 Pa of pressure. A figure showing selected spectra of element scans is available in Ref. 61. Figure 17 and Figure 18 show that the content of carbon and oxygen are lower than those of the control sample (Figure 9 and Figure 12). Surprisingly, there is a noticeable difference between the one week Mars gas sample and the one week CO<sub>2</sub> sample. First, there is very little carbon below the sample surface (where the carbon presence is due to surface contamination) for the one-week Mars

gas sample that is significantly lower than that of the one-week CO<sub>2</sub> sample. Second, the overall oxygen content is lower in the sample exposed to the Mars gas for one week, and the oxygen content drops more quickly below the surface. Furthermore, below the surface, the aluminum peak has a higher binding energy component (Figure 20), indicating the presence of aluminum oxide. When comparing the results of the sample exposed for 1 week to Mars gas to those of the sample exposed for 1 week CO<sub>2</sub>, it appears that in the Mars gas, a thinner, yet more protective oxygen-containing layer, is formed, thus preventing further interaction between the metal and the gas environment. One logical explanation for these results is the formation of a thin oxide layer by the interaction between the aluminum alloy sample and the small amount of oxygen present in the Mars gas, which prevents further interaction between CO<sub>2</sub> and the aluminum sample. This will result in very little carbon below the sample surface and in the overall low oxygen content. The other elements were present at the levels expected based on the composition of the alloy. There is some surface enrichment of Mg and Zn where the Mg enrichment is slightly more pronounced. In order to confirm these results, two additional exposures to Mars gas were conducted: a shorter one for two days and a longer one for two weeks.

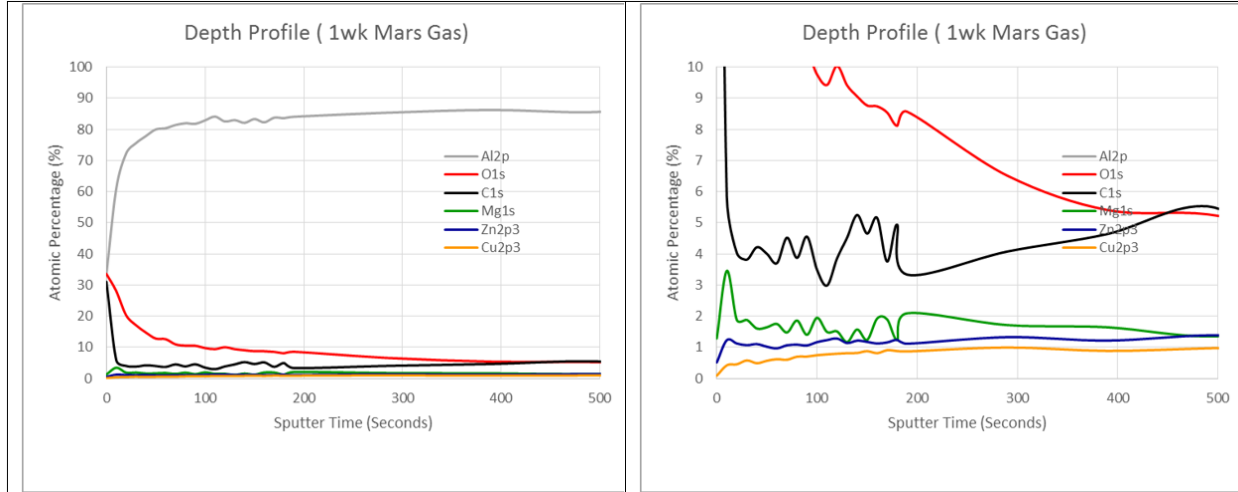
Figure 18. Depth profile data collected over the scribed area of an AA7075-T73 alloy sample, immediately after exposure to Mars gas for one week, zoomed in for 0-500 seconds etch time (left image) and for 0-10 atomic percentage (right image).

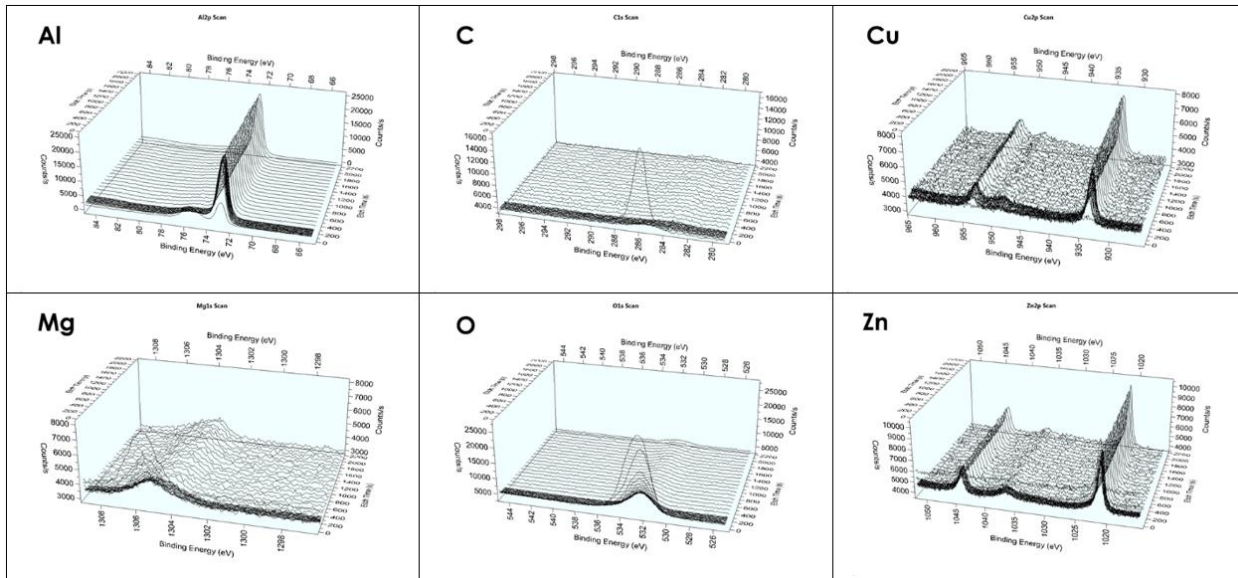
Figure 19. Depth profile data, for individual elements, collected over the scribed area of an AA7075-T73 alloy exposed to Mars gas for one week at a temperature of 20°C and a pressure of 700 Pa.

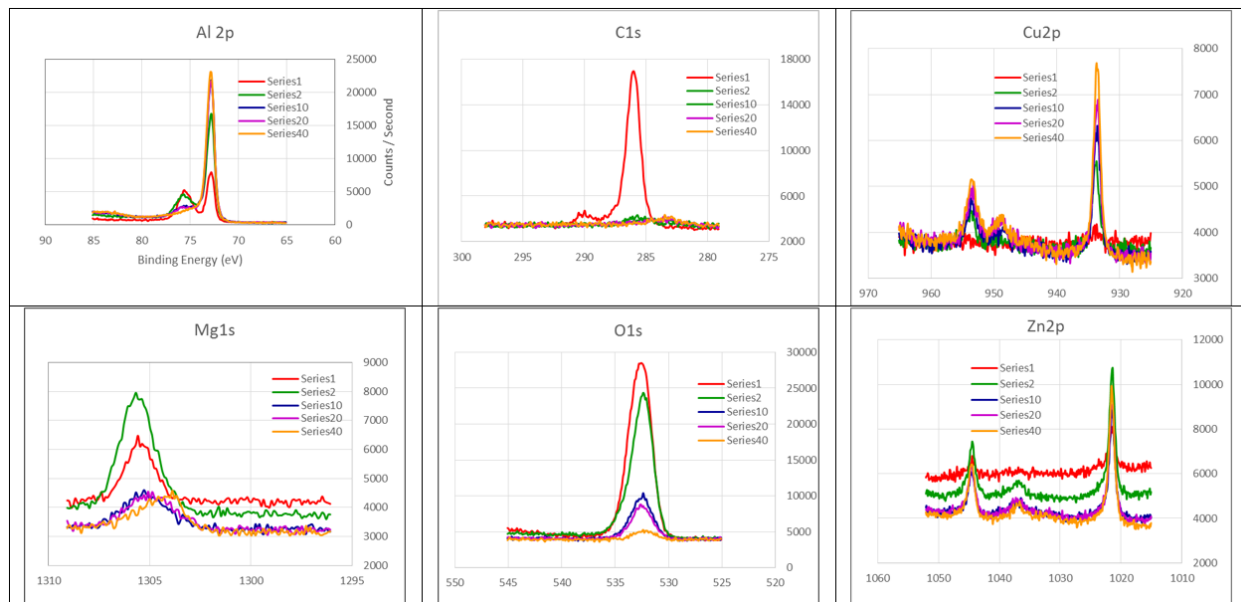
**Figure 20. Selected spectra of individual element scans from the depth profile data collected over the scribed area of an AA7075-T73 alloy sample exposed to Mars gas for one week at room temperature and a pressure of 700 Pa (7 mbar).**
